FINAL REPORT

BUILDING EVALUATION

LINDENHURST FIRE DEPARTMENT

Project No. 2733

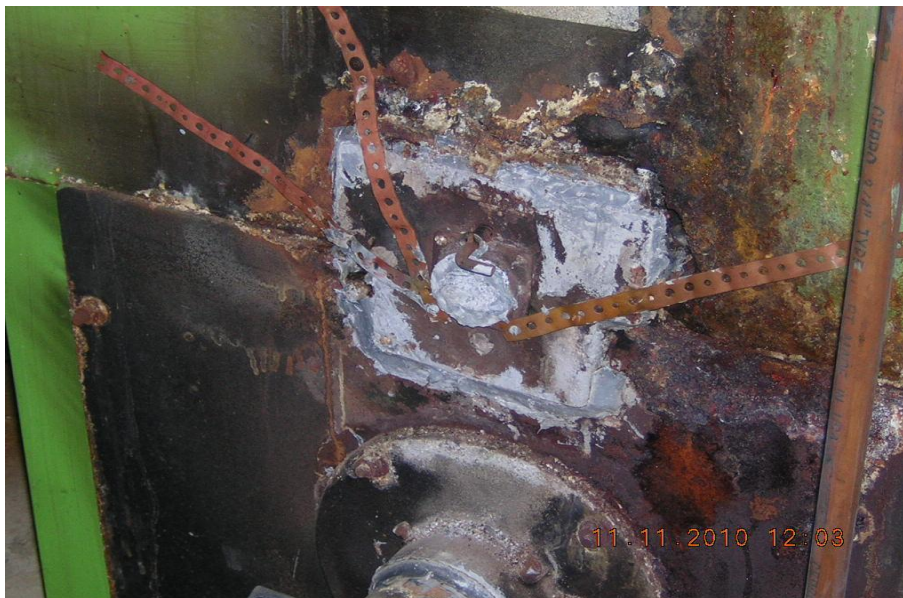
The inspection started in the west mechanical room with a review of the boiler and associated mechanical components. The boiler is an oil fired Peerless unit, with no nameplate data visible. The boiler was found to be in extremely poor condition, with a significant hole in the front as seen in the photo below:

In addition, the P&T relief valve had a significant leak, there was minimal pipe insulation and the boiler flue pipe was not pitched back to the boiler. Finally, there have been a series of puff-backs from the boiler along with the unit having on-going operational problems (repeated boiler shutdowns were observed during the course of this inspection).

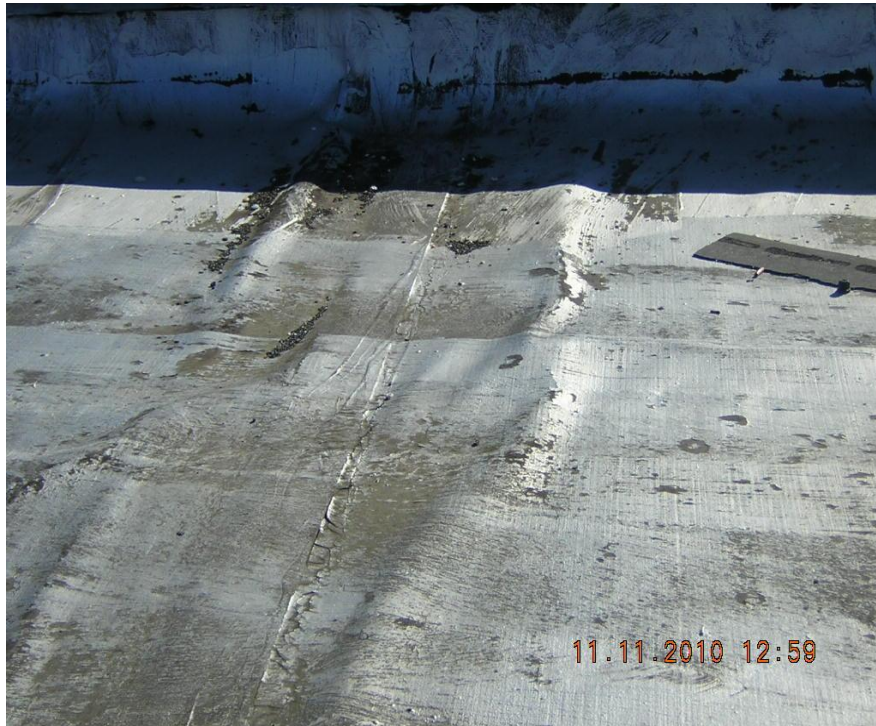
The roof was inspected next, with access gained through the fire department’s aerial truck. The roof surface was found to be in very poor condition, with significant “soft spots” noted throughout the roof. It is unclear, until further exploratory investigations are conducted, as to whether the poor roof condition extends into the roof deck, making the roof structure completely unsafe. As a result of the initial observations of the roof there is great concern that the existing roof deck may have extensive damage resulting from water intrusion. This opinion is supported by observations made of the roof deck sagging under portions of the antenna frame and sagging of the roof deck between adjoining roof rafters (as seen in the photo below).

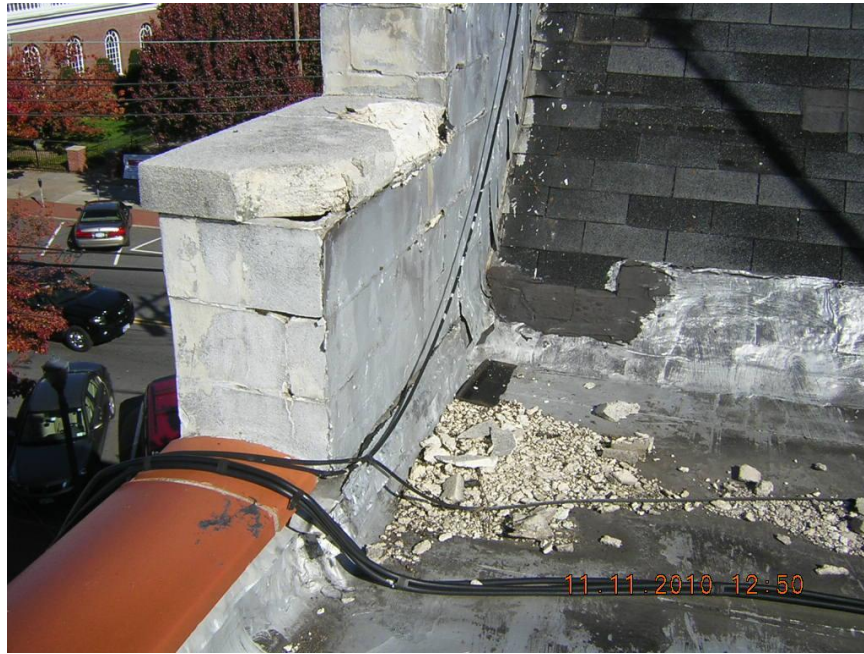
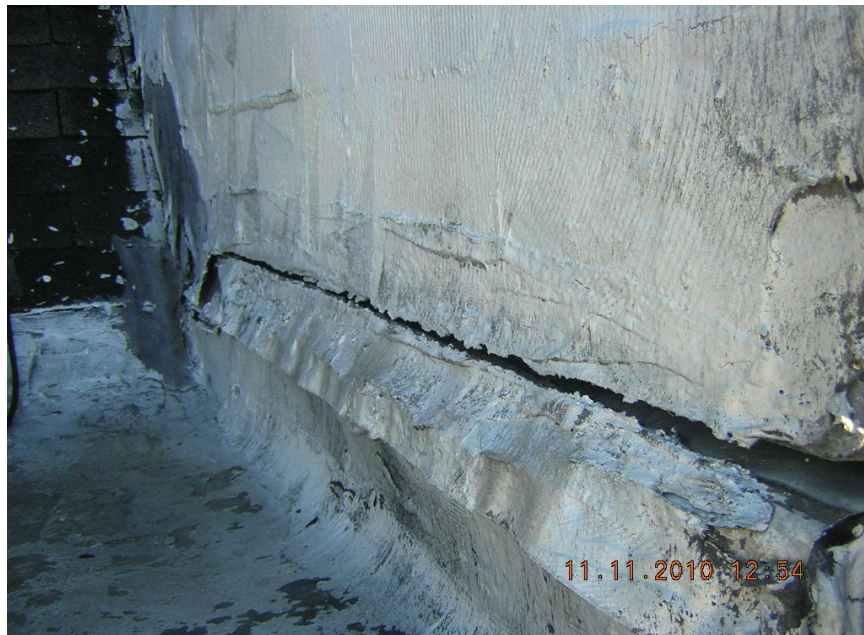
Along the north and south sides of the building combination masonry and terra cotta parapets have been installed, with the parapet sections at the northeast and southeast corners increasing in height to follow a framed mansard roof line along the east side of the building. These northeast and southeast portions of the parapet are in extremely poor condition and currently represent a structural safety concern to individuals at grade. These sections of parapet were found to have terra cotta caps that have decayed to such an extent that significant portions of the structure have fallen to the roof and grade below. In addition, cracks were discovered in the parapets that were found to translate completely through the masonry structure (from the inside surface to the outside surface) suggesting that entire portions of the parapet have now become unstable and at risk of complete collapse (see photos below):

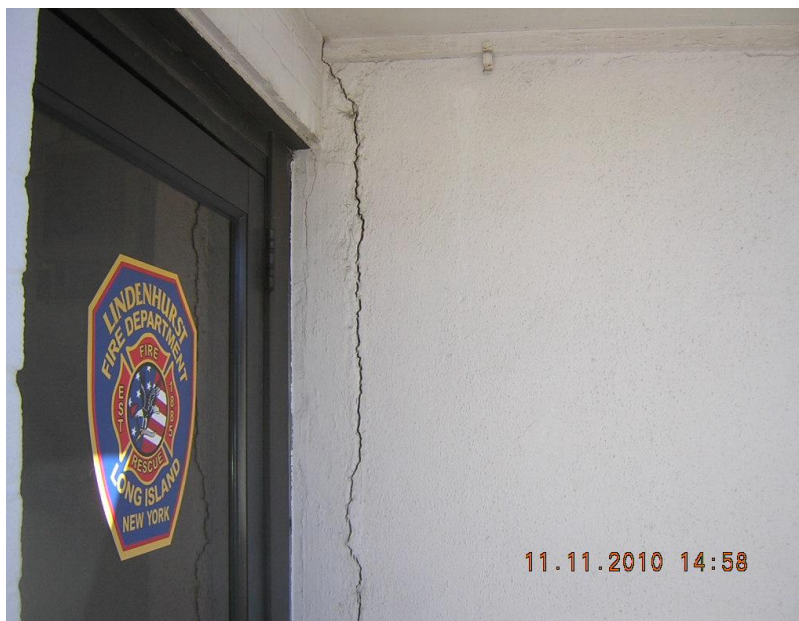
The emergency generator room was inspected and found to be in a state of significant differential settlement in relation to the existing base building structure. The junction of the generator room and the base building exterior wall consists of a significant opening in the joining surfaces, with the largest portion of the crack at the top of the wall and the smallest at the bottom of the wall. The crack is of such width that one can clearly see through the crack to the opposite side of the wall. This type of crack is indicative of a differential settlement of the adjoining structures, with the generator room pulling off the main building (see photo below):

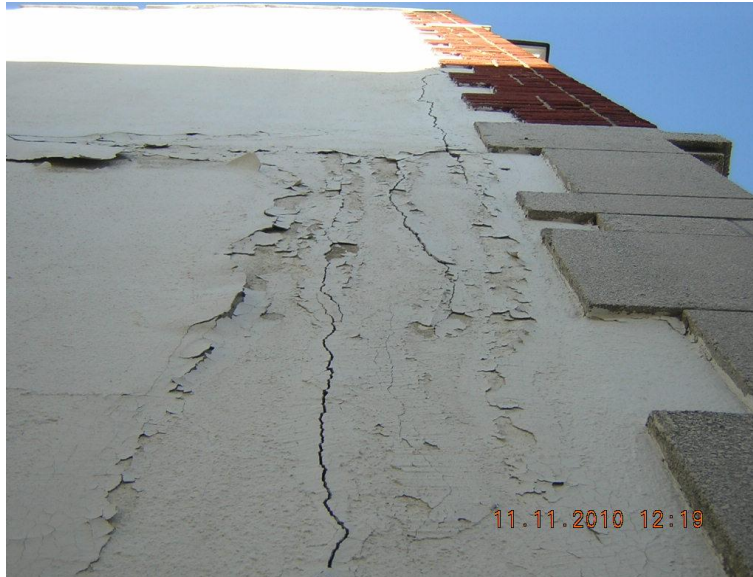
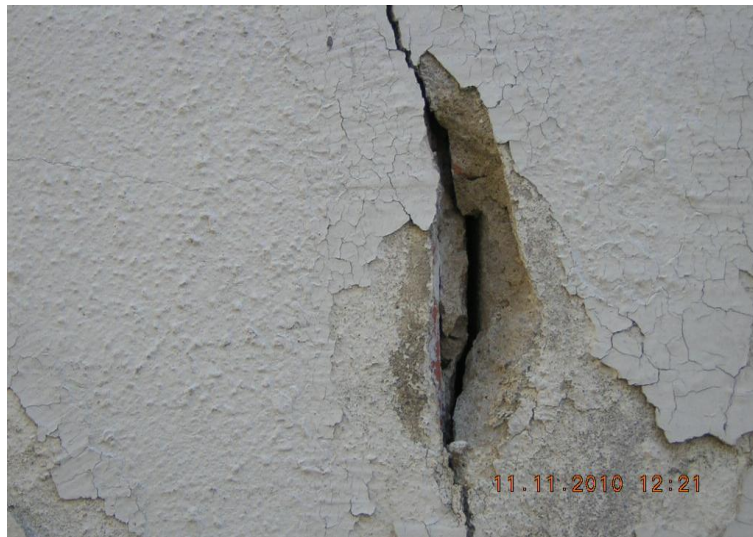
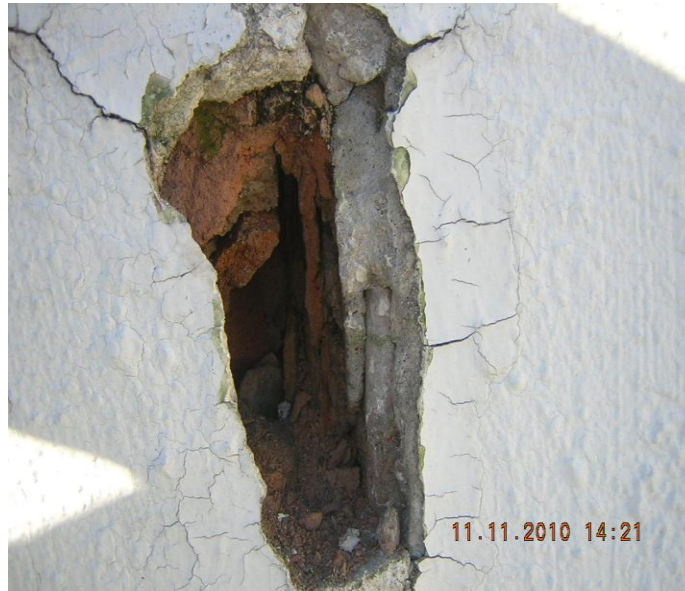
Finally, the exterior of the building was examined with specific attention given to the south side of the structure. At the far east end of the south wall, significant vertical cracks were discovered that include one portion that measured approximately 26 inches long and varied from 1/8" to 1-1/4" in width. In addition, tapping on the wall in this region resulted in "hollow" sounds suggesting that the underlying structure has fractured. Furthermore, at the far west end of the south wall, additional cracks were discovered, with one portion of the crack resulting in a hole approximately 2-1/2" by 6". In both cases, the holes appear to be in regions where the base building structure consists of terra cotta block, with the exterior core of the blocks being the region of failure. Finally, at the east end of the wall, the significant vertical cracks appear to be located at a point where the terra cotta structure has been installed adjacent to an existing brick structure (see photos below).

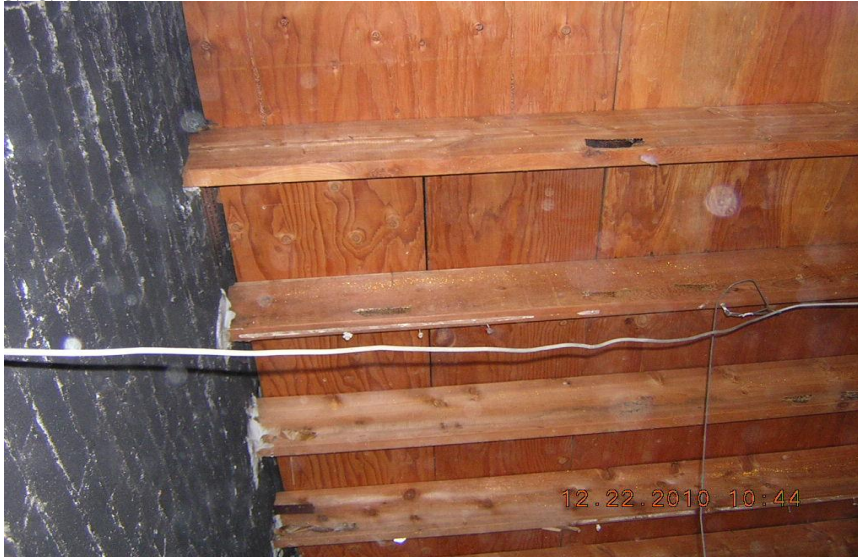
The inspection on 22 December was conducted to examine the underside of the roof deck that was inaccessible during my initial inspection of 11 November. At the time of this inspection, large sections of the meeting room ceiling had been removed along with portions of the GWB attached to the underside of the roof structure. The existing roof structure (comprised of 2x8 rafters at 16” o.c. and approximately 16’-0” in span) appeared to be in very good condition. There were no visible signs of rot or decay, nor any signs of structural failure as seen in the photo below:

While the existing roof structure appeared to be in good condition, it should be noted that the roof rafters are under sized for their existing span (maximum projected bending stresses may reach values that exceed the maximum allowable for typical doug-fir lumber by upwards of 56%). Furthermore, the fire department was advised to remove all remaining ceiling structure and underlying GWB so as to allow the existing roof structure and sheathing to “dry out” (as a reminder, in my initial inspection it was noted that the roof deck, from the exterior roof side, was in extremely poor condition, with concern that water had infiltrated the roof insulation or sheathing).

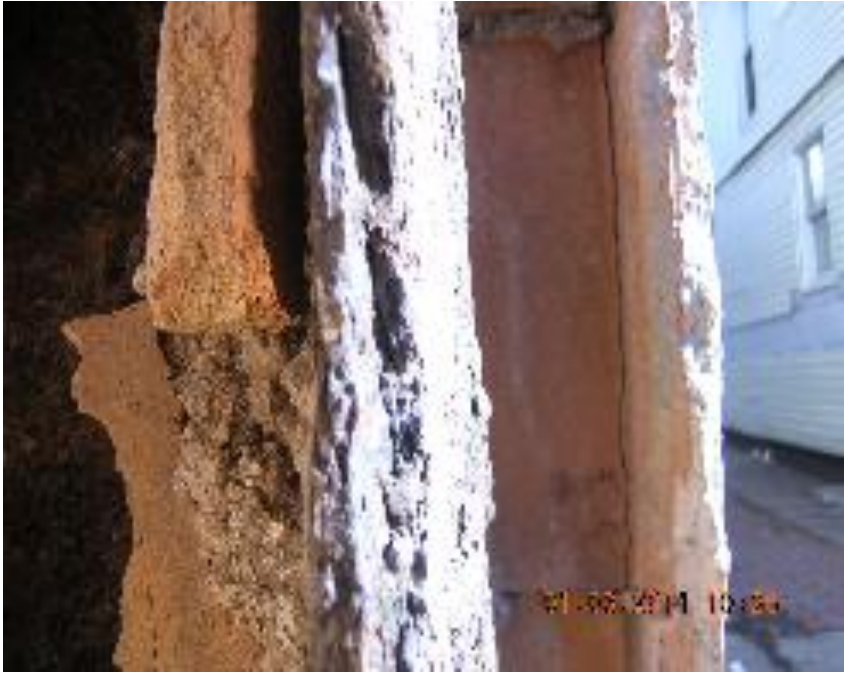
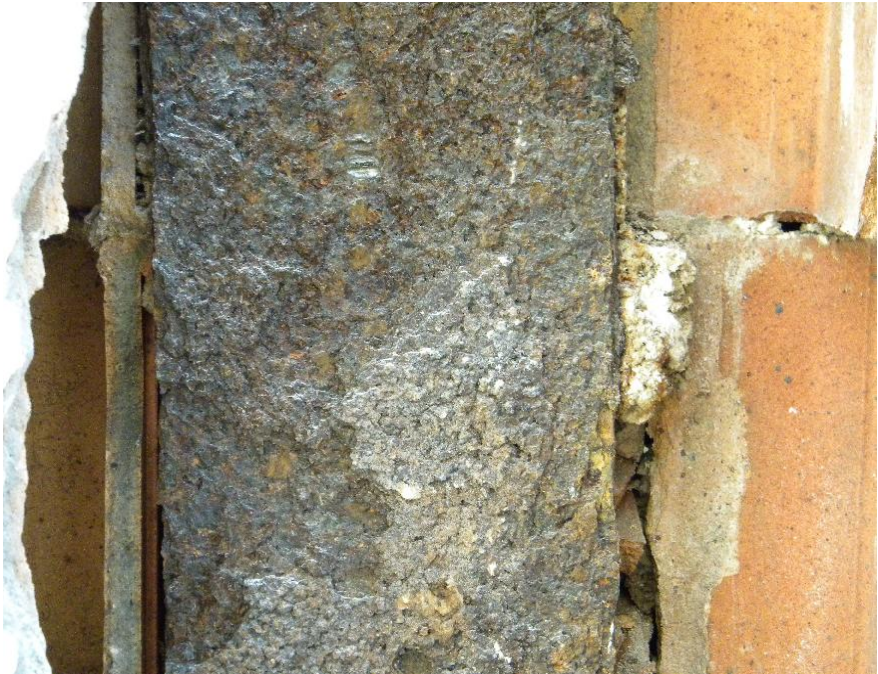
On 30 December and 3 January, site visits were conducted to observe the condition of the existing steel columns located within the south wall of the building. A contractor retained by the owner removed portions of the existing terra cotta block and any associated in-fill material so as to allow for an examination of the steel columns for any signs of potential failure or decay. Two columns were partially exposed to allow for a visual inspection of the outside (south facing) column flange and, to a very limited degree, the column web. The flange was found to have a significant amount of rust (with partial material degradation on the outside edges of the flange), but with no apparent through rust decay of the column flange, as seen in the photos below:

The rust and decay in the column flange may be addressed through future sandblasting of the steel and the welding of a steel plate to the outside of the existing flange surface.

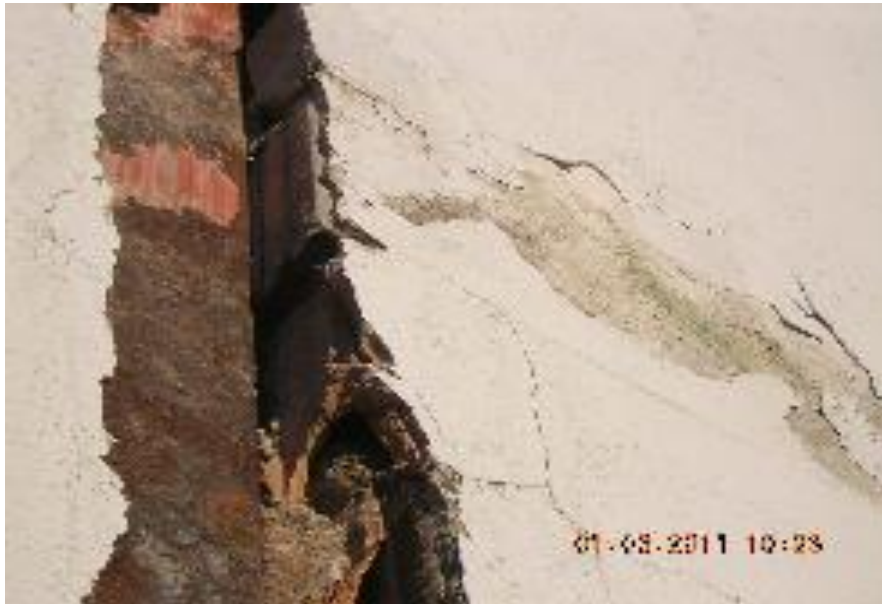
Next, the terra cotta and CMU blocks were examined (where made visible through the removal of material to examine the steel columns). The horizontal crack that runs east and west, approximately halfway up the north and south walls, may be attributed to the differential movement between the terra cotta and CMU blocks (this crack aligns closely with this change in building material as may be seen in the photo below).

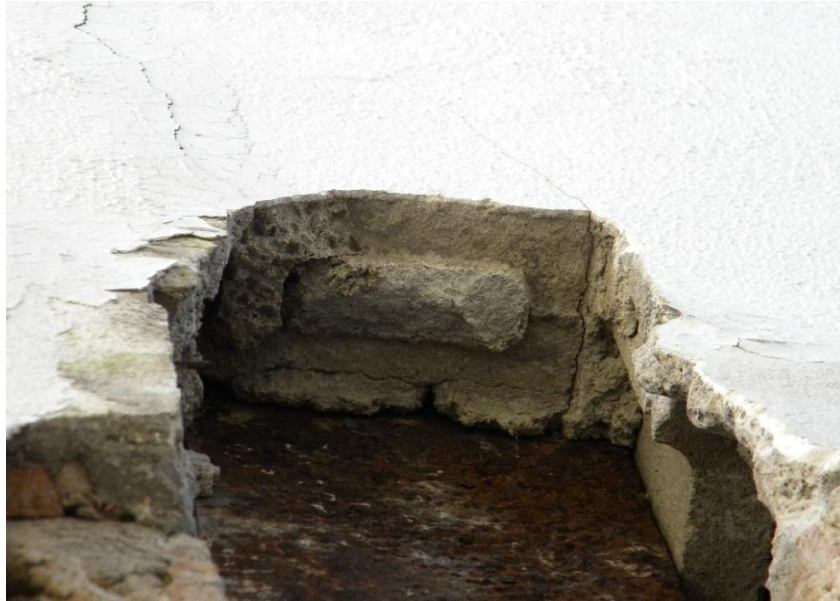
The lack of any apparent vertical or horizontal reinforcement in either block will result in the lack of stability in bending (as would occur during extreme wind loading or transverse loadings due to seismic conditions) and will additionally create a potential “hinge” at the point of transition between the two block materials, resulting (in part) in the horizontal crack that may be observed. Finally, the installation of “fill material” between the inner and outer flanges (adjoining the web) and on the outside of the outer flange, has created additional vertical cracks (at locations near the steel columns) due to the shifting of this unstable material, as may be seen in the photo below:
